PLATE FREEZER CONTROL PANEL

IR000095.IS2

2/3/2010

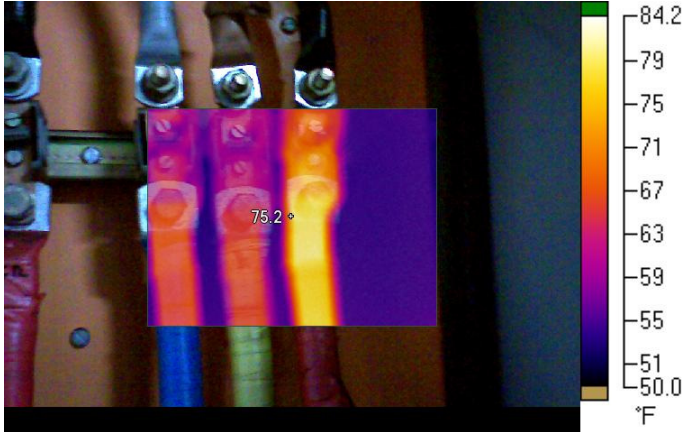
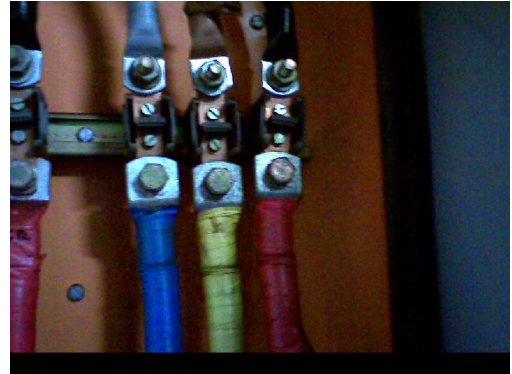
UNEVEN LOAD / CURRENT BEING DRAWN BETWEEN PHASES

No visual signs of any defects

Background Temperature	69.8°F
Emissivity	0.95
Average Temperature	62.0°F
Image Range	53.3°F to 81.7°F
Camera Serial Number	Ti25-09031331
Manufacturer	Fluke

Name	Temperature
Centerpoint	75.2°F
